**DRAFT
SITE ASSESSMENT REPORT
DETROIT COLD ROLLING
GIBRALTAR, WAYNE COUNTY, MICHIGAN**

Date Prepared	December 12, 2007
TDD Number	S05-0002-0706-009
Document Control Number	214-2A-ABKJ
Contract Number	EP-S5-06-04
WESTON START Project Manager	Alex Clark
Telephone Number	(313) 739-2533
US EPA On-Scene Coordinator	Brian Schlieger

December 12, 2007

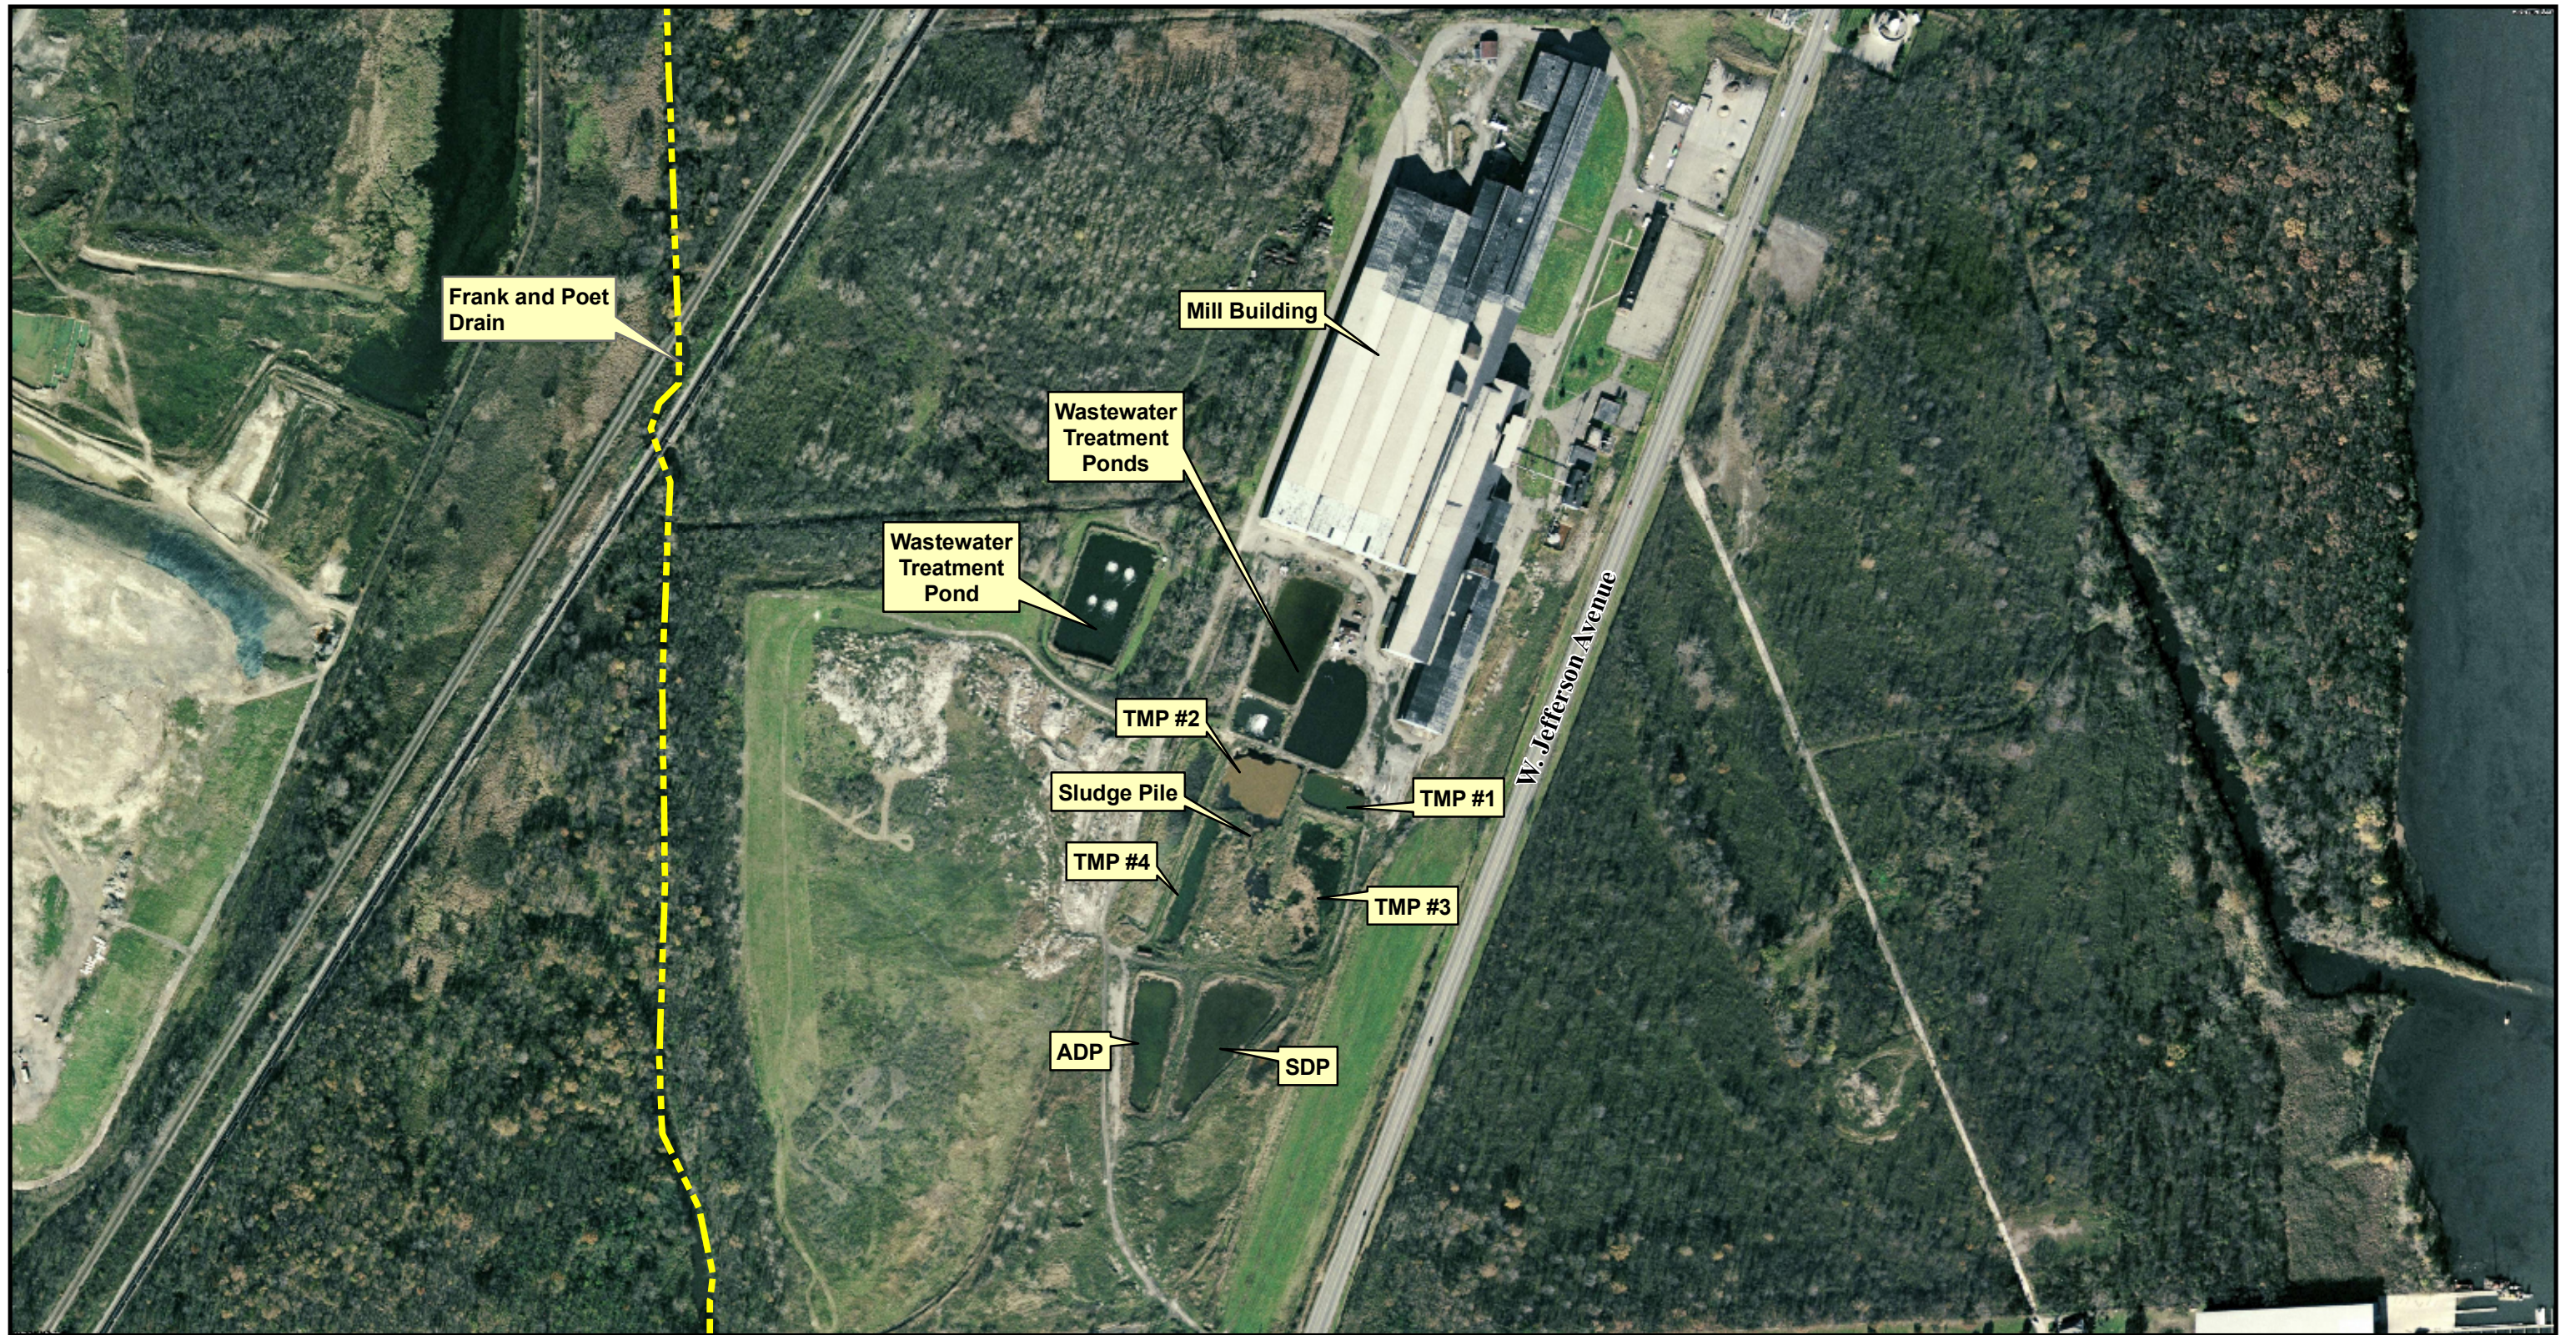
Figure 2

The entrance to the Site is located on the east side of the Site and faces W. Jefferson Avenue (**Figure 2** in Appendix A). The Site's entrance is gated with a posted security guard. WESTON START observed a chain-link fence surrounding the eastern and northern perimeter of the Site. Vegetation covers the fencing on the eastern perimeter of the Site. WESTON START did not inspect the southern and western perimeters of the Site as the focus was the TMP, ADP, and SDP.

Several ponds are located south of the DCR facility. Three retention basins are located immediately to the south of the DCR facility that serve as leachate collection ponds for the landfills to the west of the TMP (**Figure 2** in Appendix A). The TMP is located south of the three leachate collection ponds and was observed to be sectioned into at least four smaller ponds. Each section of the TMP is divided by soil and gravel berms with overgrown vegetation along most berms. The OSC labeled the four TMP sections one through four, as shown on **Figure 2**. Two larger ponds, the ADP and SDP, are located south of the TMP. WESTON START observed an area of oily sludge located south of TMP#2. The sludge is suspected to be dredge spoils from previous TMP dredging activities. Representative photographs of the sludge are provided in **Appendix C**.
